Cold Engine Tick Noise (Replace Pistons) #01-06-01-005

2000-2001 Buick Century

2000-2001 Chevrolet Lumina, Malibu

2000-2001 Pontiac Gran Prix

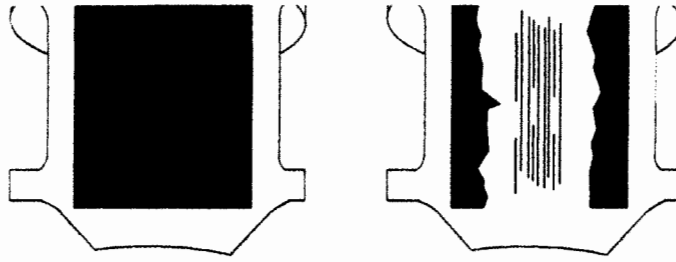
Removal of pistons from engine cylinders 5 and 6 is NOT necessary if equipped with polymer coated pistons. It is recommended to rotate the crankshaft until the piston skirt is exposed in the lower crankcase area for inspection. Replace pistons in engine cylinder positions 5 and 6 ONLY if there is evidence of damage to the polymer coating on the piston skirt, or cylinder wall wall (heavy scratches) is evident.

- (1) Good Piston
- (2) Scored Piston

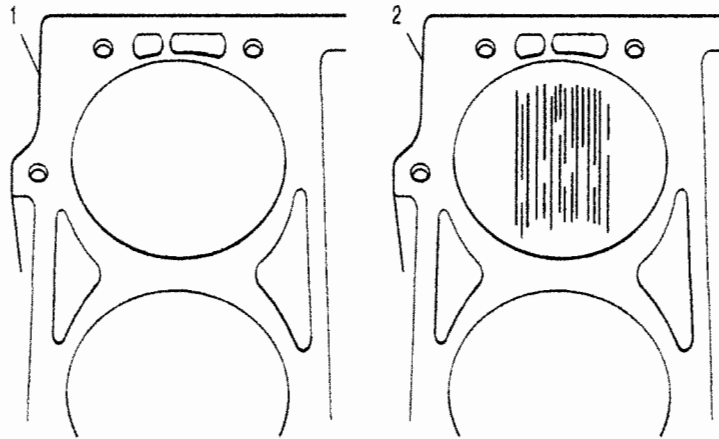
FIGURE Cylinder Wall Finish(c)

- (1) Good Cylinder Wall*
- (2) Scored Cylinder Wall*

- ① Provided for illustration purposes only. Actual orientation of scuffing on cylinder wall
